CASE STUDY

Pipeline Fuel Spill – Little River, Victoria

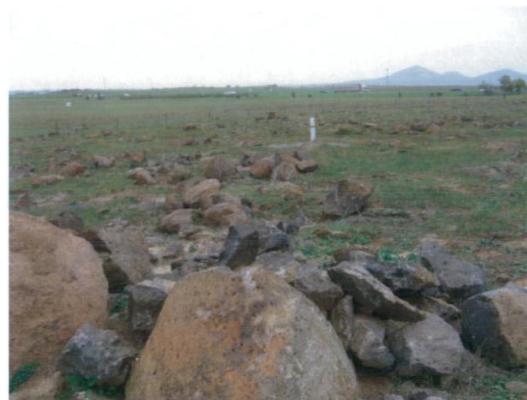
In May 2004, the EPA confirmed fuel discharging to the land surface adjacent to the Princess Highway near Avalon airfield and near the WOPL. On investigation, Shell identified a failure in the pipe 1mm wide and approximately 80mm long where the pipe crosses over an elevated area formed by an old basalt flow (Figure 1). The pipe was subsequently repaired, and contaminated soils around the pipe excavated and removed.

FIGURE 1: ELEVATED “STONEY RISE” SHOWING THE PATH OF AN OLD LAVA FLOW.

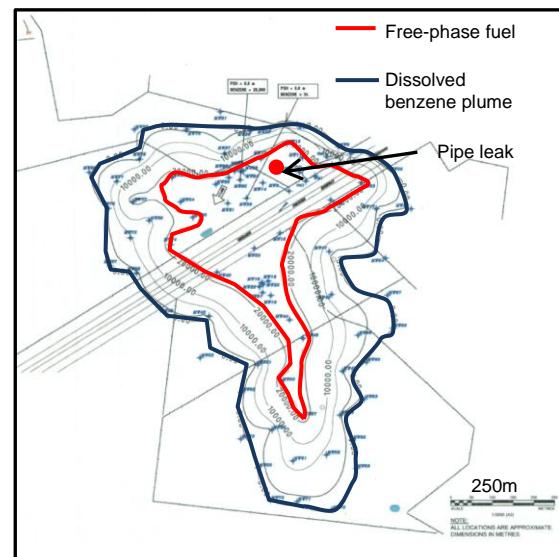
Further investigation identified an extensive plume of free phase fuels on-top of the watertable. Fuel is a Light, Non-Aqueous Phase Liquid (LNAPL) – that is when it leaks it floats on top of the groundwater as free fuel (Figure 2). Some fuel dissolves into the groundwater to form a further dissolved plume of contaminated groundwater (Figure 3).

The free phase fuel flows in fractures in the basalt (Figure 4) in the direction of the watertable surface. This resulted in fuel products flowing beneath the Princess Highway and toward Port Phillip Bay. The dissolved phase plume mirrored the free phase plume, but had spread further.

FIGURE 3: EXTENT OF FREE PHASE FUEL (LNAPL) AND DISSOLVED CONTAMINANT (BENZENE) PLUME

Remediation commenced on the south side of the Princess Highway to ensure the fuel did not continue to move toward Port Phillip Bay. In order to separate the fuels and treat the water effectively, a dedicated treatment plant was set up. A network of bores brought fuel and groundwater to the treatment plant. Where possible, free fuel was removed and recycled. The water was then oxygenated to assist degradation of the dissolved contaminants, and then re-injected into the groundwater. In the late 2000's, a second separation system was set up on the north side of the highway to extract free phase fuel. Clean-up of the site is ongoing.

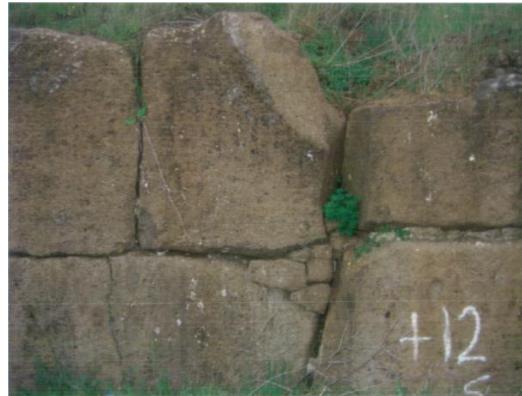
FIGURE 4: FRACTURES IN THE BASALT ALLOW WATER AND FUEL TO MOVE THROUGH THE ROCK.
