CASE STUDY

Pipeline Fuel Spill – Little River, Victoria

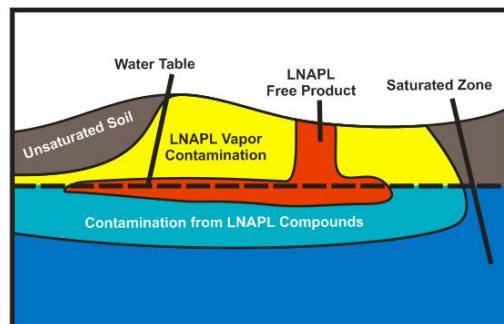
FIGURE 2: HOW LNAPL MOVES AND DISSOLVES

Further investigation identified an extensive plume of free phase fuels on-top of the watertable. Fuel is a Light, Non-Aqueous Phase Liquid (LNAPL) – that is when it leaks it floats on top of the groundwater as free fuel (Figure 2). Some fuel dissolves into the groundwater to form a further dissolved plume of contaminated groundwater (Figure 3).
